Horror in a Haunted Castle

How did the fire in the Haunted Castle start? Why were eight teenagers unable to reach safety? How could fire protection and early warning systems have helped to avert this disaster?

Castle: *The Tragedy/The Investigation*

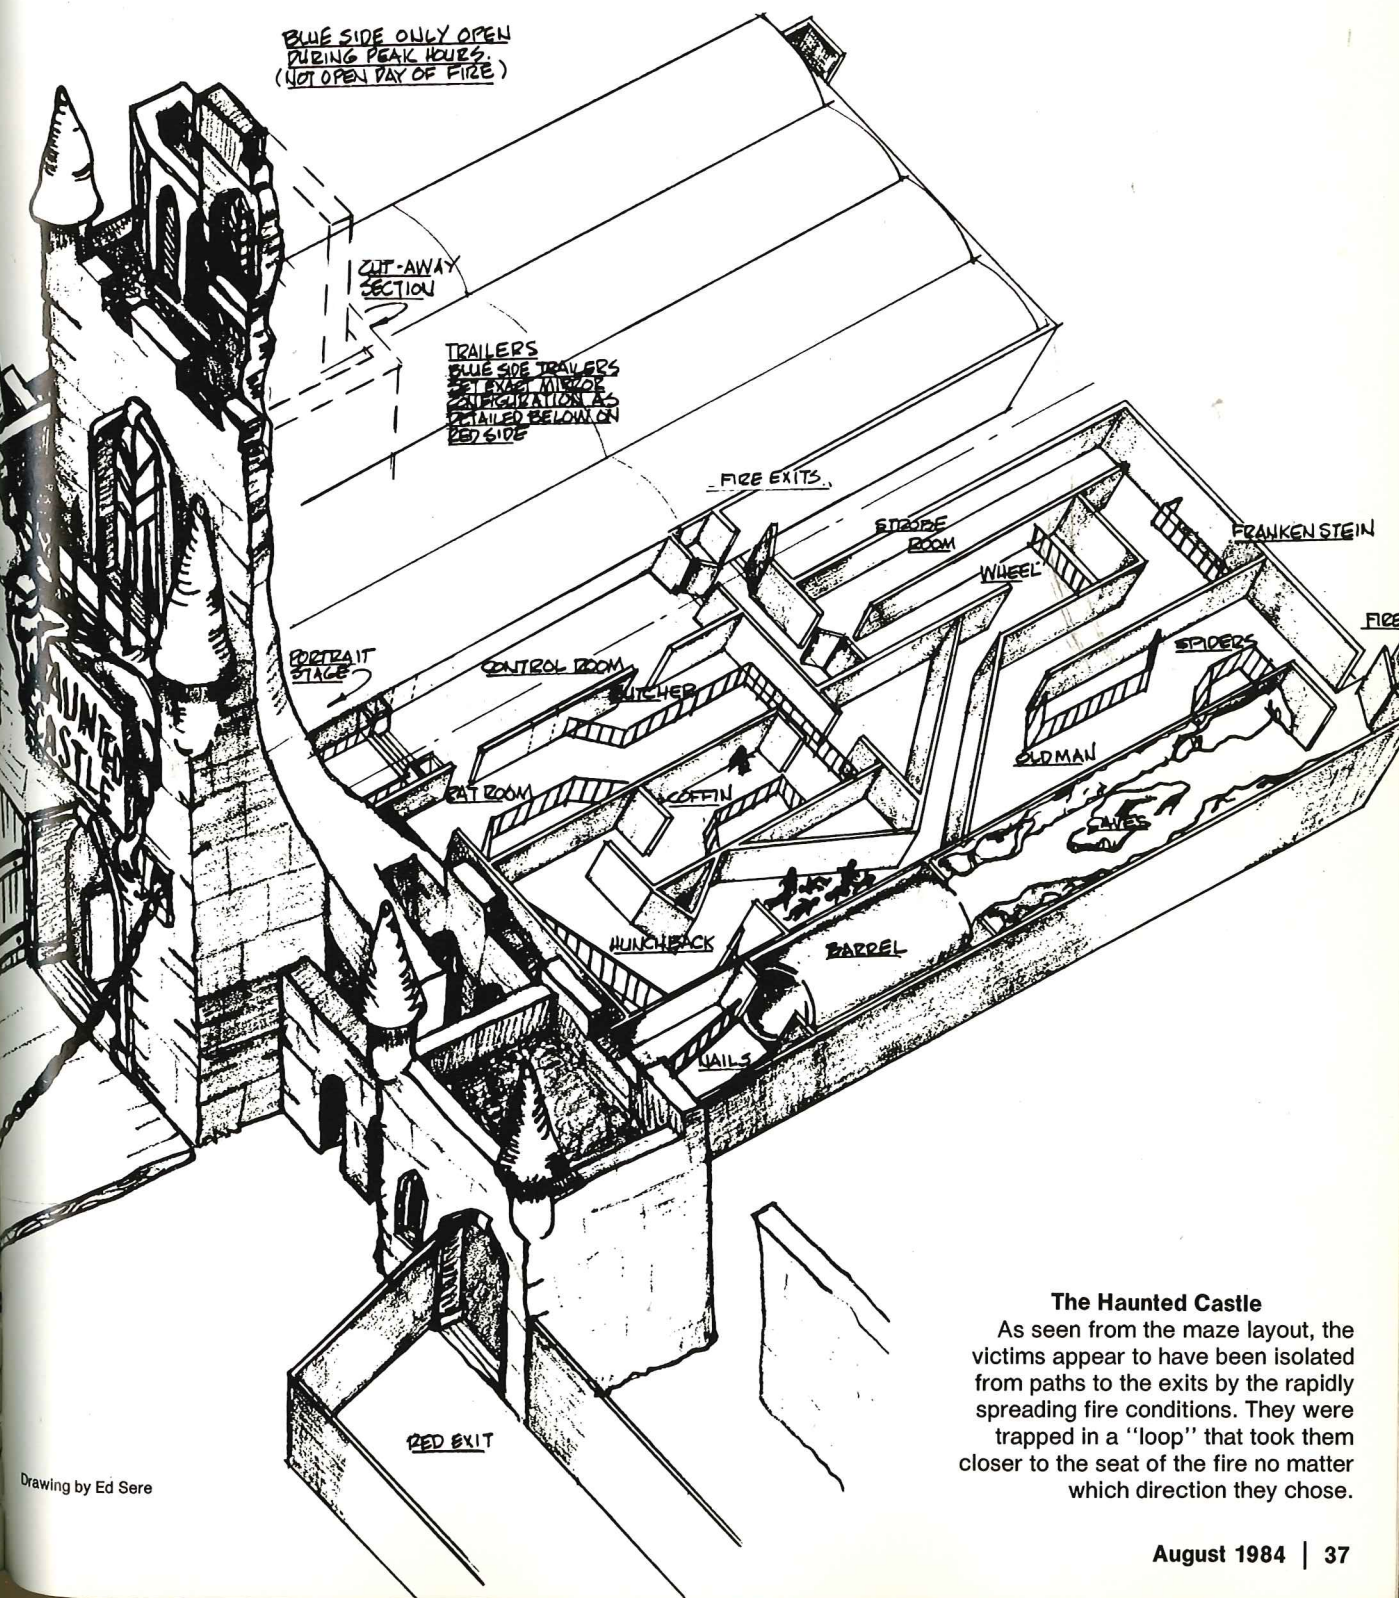
The Haunted Castle

As seen from the maze layout, the victims appear to have been isolated from paths to the exits by the rapidly spreading fire conditions. They were trapped in a "loop" that took them closer to the seat of the fire no matter which direction they chose.

When conditions permitted, a thorough secondary search was conducted. The bodies of the eight trapped victims were located at that time. They were found in a loop section of the maze. The teenagers didn't have much of a chance to escape the fast toxic buildup of copious amounts of heated black smoke followed by a fast flame spread from both the rear and the front due to the loop in the maze.

The travel distance through the castle was 458 feet. From the entrance to the first emergency exit was 226 feet. A second emergency exit was another 100 feet, and 118 feet to the final exit. The first victim was discovered approximately 100 feet from the entrance and the remaining seven were found 120 feet into the castle. ■

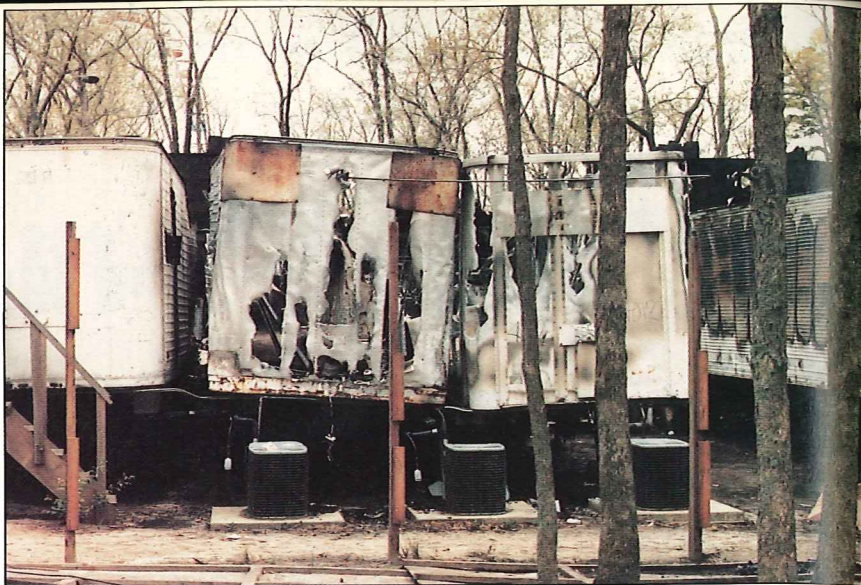
From left to right, the rear of the spider, frankenstein, and strobe room trailers (the latter being the point of fire origin) show the effects of the heat generated. The air circulating units that intensified the fast-moving fire are located in the foreground.

On his arrival at the fire, Chief Kebeck received a report that all occupants had been evacuated. Disregarding this, search operations were continued. Initial size up indicated that the fire was being force fed from the rear of the row of trailers. It was later reported that four of the attraction's air circulating fans were operating at the rear of the trailers and contributing to the velocity of the fire.

Another major factor contributing to rapid flame spread was the four large air circulating fans.

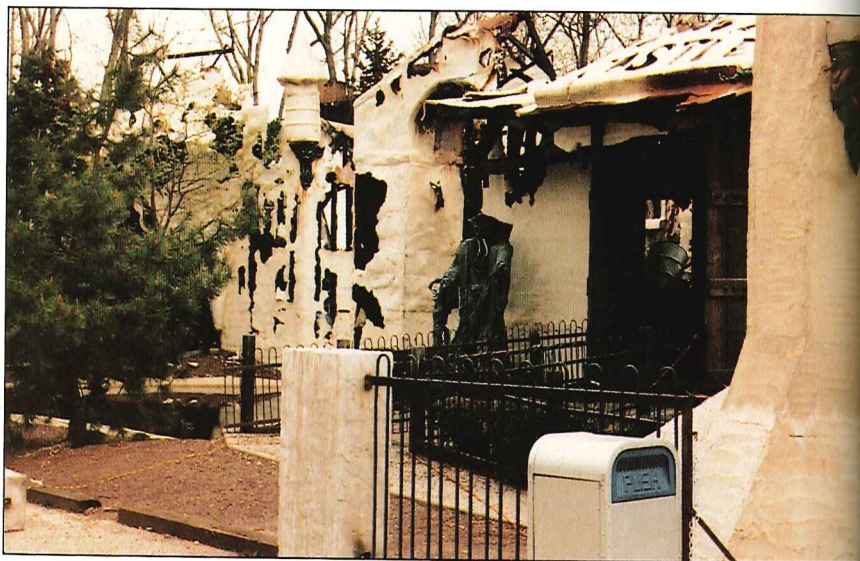
Entrance to the Haunted Castle is made even more ghastly by the deadly fire damage.

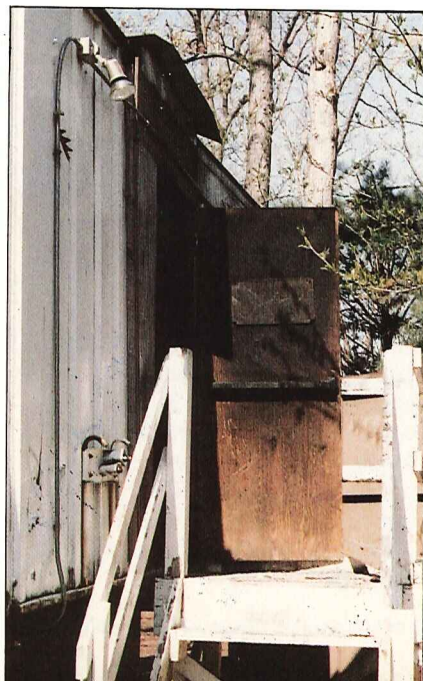
A typical exit door used in the trailer complex for emergency egress.

- The number of exits must be adequate and maintained in a safe condition at all times for a speedy flow of all occupants to safety.

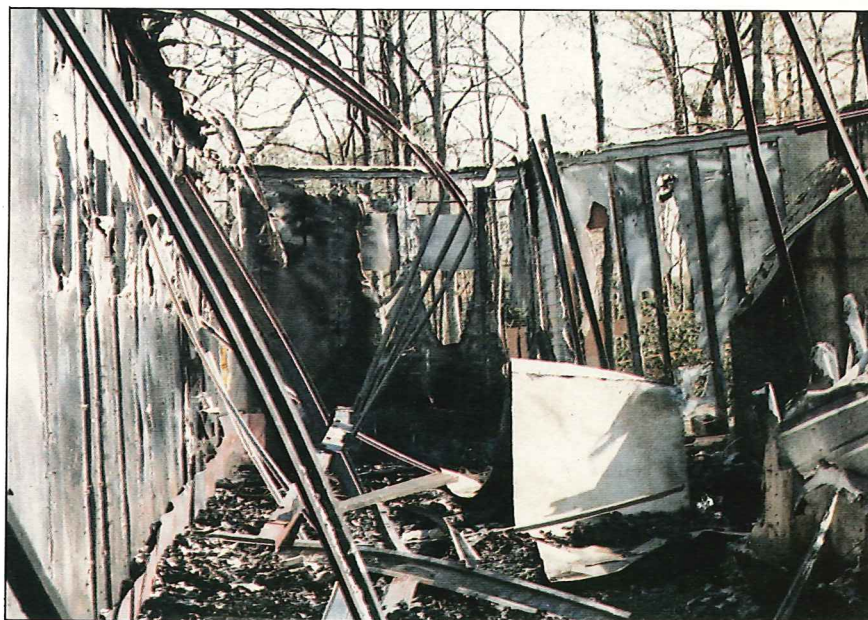
Initially there were two separate burn patterns discovered. Only intense investigation disclosed that there was a single point of fire origin.

Looking out toward the rear of the strobe trailer. The dark panel at the left rear is the polyurethane crash pad determined as the point of origin.

It was determined that at the end of the strobe room corridor was a crash pad of polyurethane foam. This was to prevent injuries to guests running through the strobe room and hitting the wall. It was also determined that the strobe light was malfunctioning on the day of the fire. It would go out for periods of three to four minutes, leaving the corridor in total darkness.

A very common practice in the castle was for the guests to light matches or lighters to see where they were going. The employees were constantly instructing the guests to put out the matches. On the night of the fire, a 14-year-old was using a lighter to see. He accidentally walked into the foam on the strobe room wall, setting it on fire. He attempted to beat it out with a canvas bag, was unsuccessful, and apparently continued through the castle.

When ignited, polyurethane foam

burns rapidly. The strobe room corridor was constructed of combustible plywood on the ceiling, floor, and walls. The fire spread rapidly down the corridor and around through the phantom of the opera section of the castle. The course of the fire effectively cut off any avenues of egress for the victims.
